# **DEATH AT THE STADIUM**

**REPORT ON THE FATAL USE OF AN EARLY STREAMER  
EMISSION LIGHTNING ROD IN MALAYSIA**

**By**  
**Z. A. Hartono & I Robiah**  
**March 2012**  
**E-mail: [zahartono@ieee.org](mailto:zahartono@ieee.org)**

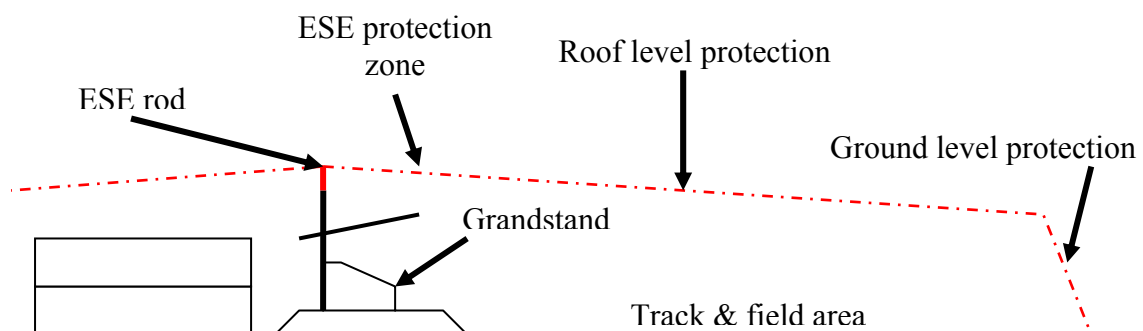
When this ESE lightning protection method is applied to the KIUM stadium, the claimed ESE protection zone will include most, if not all, of the football field and athletic track at KIUM (Fig. 10). Every project consultant who is competent in lightning protection engineering knows that buildings with robust metal roofs do not need protection against lightning strikes, hence the ESE lightning rod installed on the KIUM grandstand was for the purpose of open area protection only.

Fig. 10: The claimed ESE protection zone at the KIUM mini-stadium.

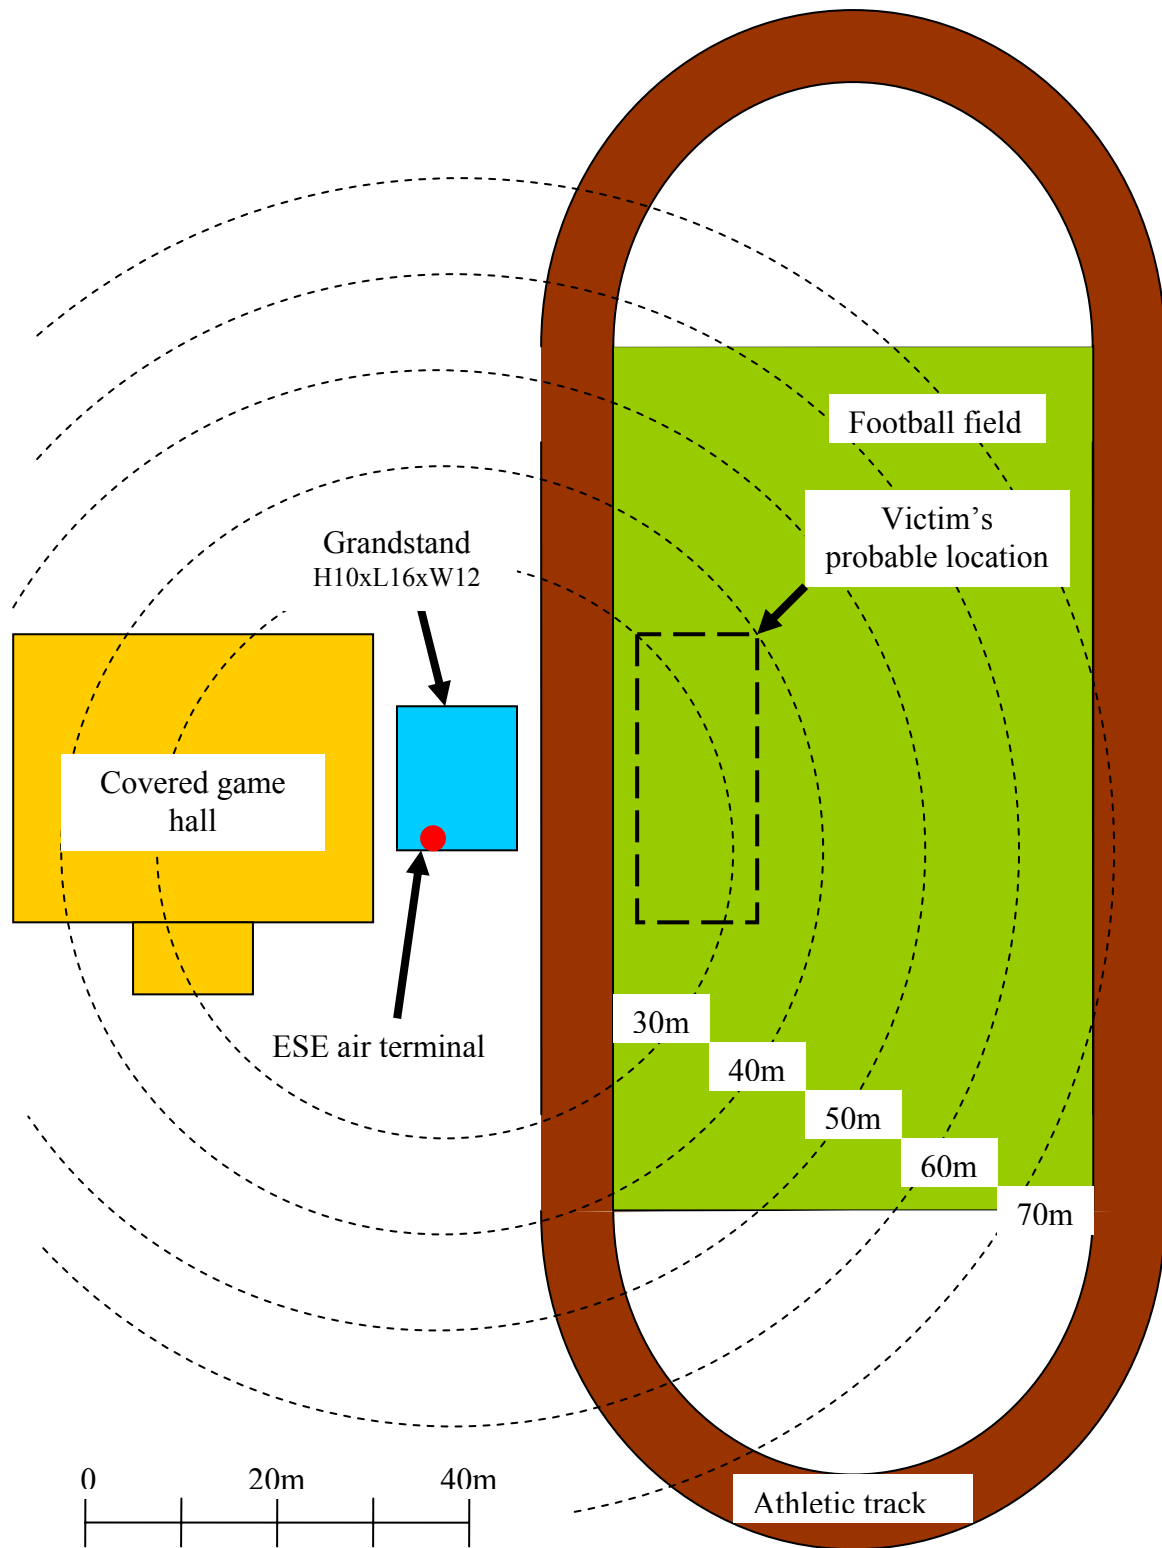
According to a news report, the victim and his friends took shelter in the grandstand when heavy rain and lightning interrupted their football practice that evening. When the downpour became a drizzle, they went down to the football field and was just about to restart their football game when the victim was struck by lightning. This would place the victim's location somewhere on the football field in front of the grandstand when he was struck i.e. within about 40 m from the ESE lightning rod (Fig. 11).

This incident is another indisputable evidence of the failure of the ESE lightning rod with fatal consequences since the victim was clearly within the claimed protection zone of the rod when he was struck by lightning. With hundreds of recreation sites around the country using the ESE lightning rods as protection for open areas, it will not be long before another student or member of the public fall victim to a direct lightning strike.

Fig. 11: Plan diagram showing the location of the ESE lightning rod and the victim.

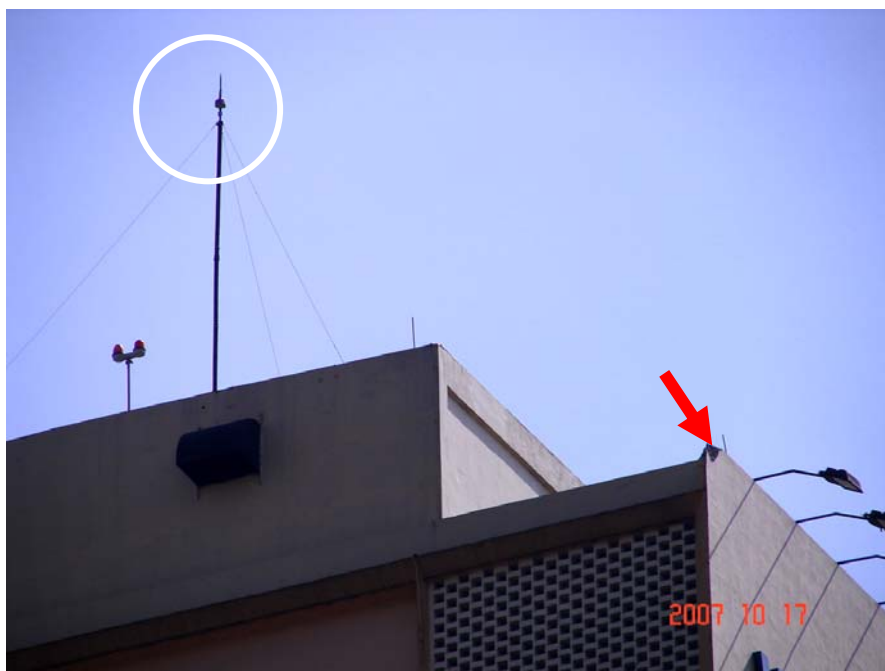
Hence, it is not surprising that the victim in this incident was struck well within the claimed ESE protection zone. In fact, the failure of the Satelit ESE lightning rod has been observed in a number of cases within Kuala Lumpur. One of them is shown below (Fig. 12).

Fig. 12: The Wisma Tanah building in 2007 (before the damage was repaired).

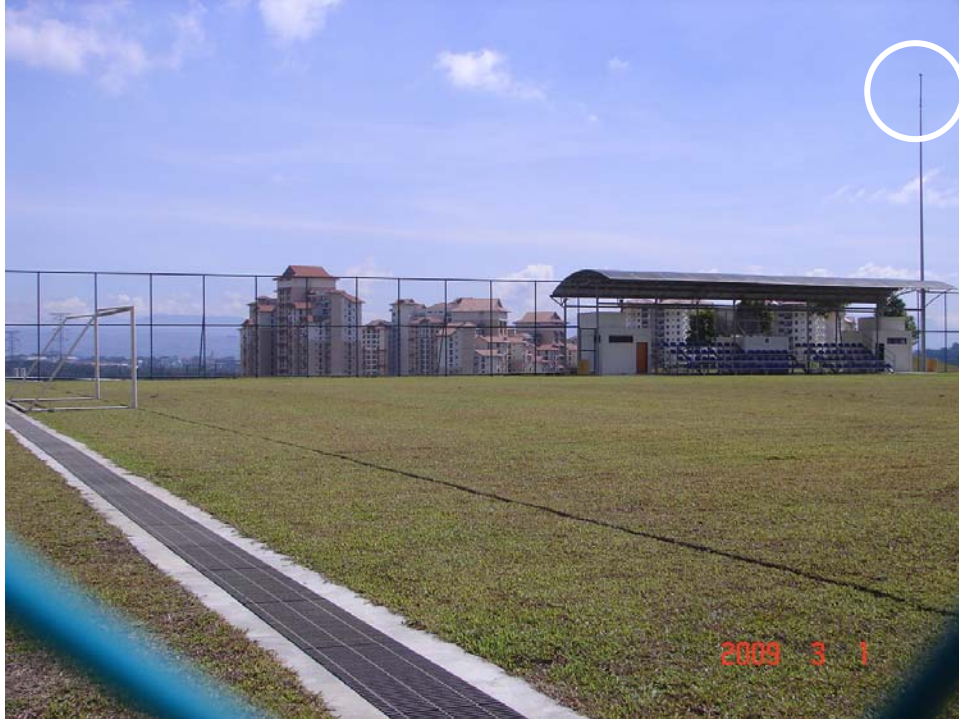
This school field is situated on top of a barren hill and is therefore considered as a high risk lightning location. An ESE lightning rod has been installed beside an all metal mini-grand stand (Figs. 13 and 14).

Fig. 13: An ESE lightning rod installed on a school field in Putrajaya.

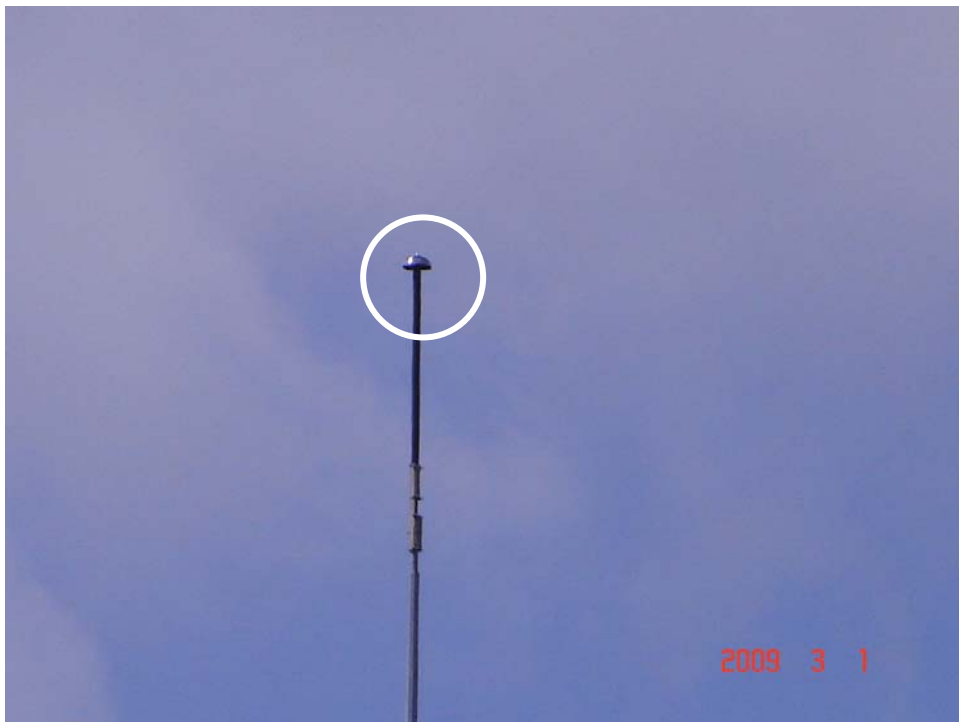
Fig. 14: A close-up photograph of the ESE lightning rod.
