# LIGHTNING PROTECTION SYSTEMS

**OPERATION &  
MAINTENANCE FOR  
BUILDING OWNERS**

**Harger Lightning & Grounding**

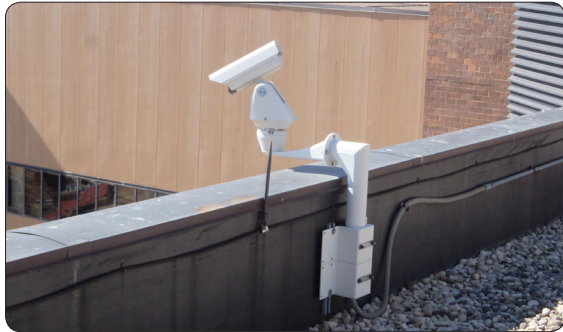
## SECURITY SYSTEMS

Updated security cameras were recently installed on a large, regional medical center. The camera is susceptible to damage from a lightning strike which could further cause additional interior damage from fire due to arcing between the CCTV system and other building systems.

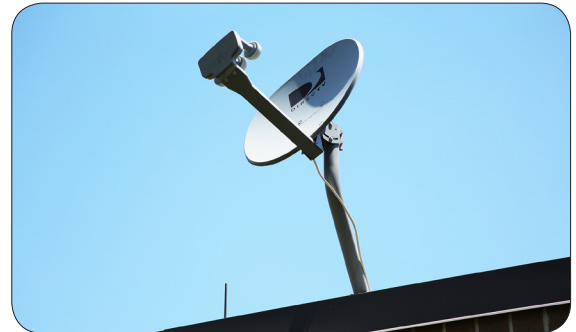
## SATELLITE DISH

A satellite dish was recently added to a corporate headquarters as a backup source for internet services. The existing lightning protection system does not adequately protect this new telecommunications addition. Satellite dishes require special considerations as the protection method cannot interfere with the operation or reliability of the incoming and outgoing signals.

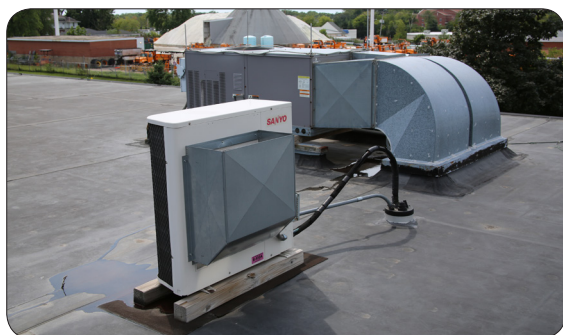
## NEW HVAC EQUIPMENT

A new cooling unit was installed for a computer server room and was not tied into the lightning protection system. This unit is a mission critical piece of equipment which needs to be operational at all times. The financial implications of this unit suffering damage caused by a lightning strike makes it very clear that the existing system needs to be updated.

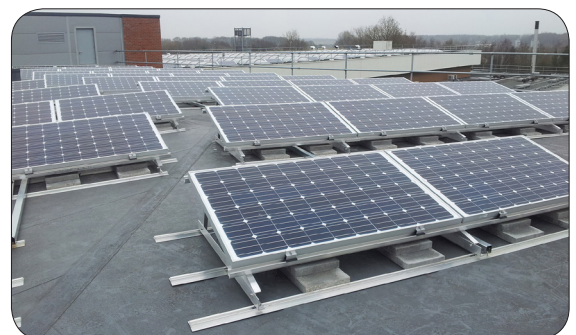
## SOLAR PANELS

Multiple solar panel arrays have been added to a roof with an existing lightning protection system. It is imperative to prevent damage to the panels by promptly and effectively incorporating the new solar panel arrays into the existing lightning protection system.
