# **DEATH AT THE STADIUM**

**REPORT ON THE FATAL USE OF AN EARLY STREAMER  
EMISSION LIGHTNING ROD IN MALAYSIA**

**By**  
**Z. A. Hartono & I Robiah**  
**March 2012**  
**E-mail: [zahartono@ieee.org](mailto:zahartono@ieee.org)**

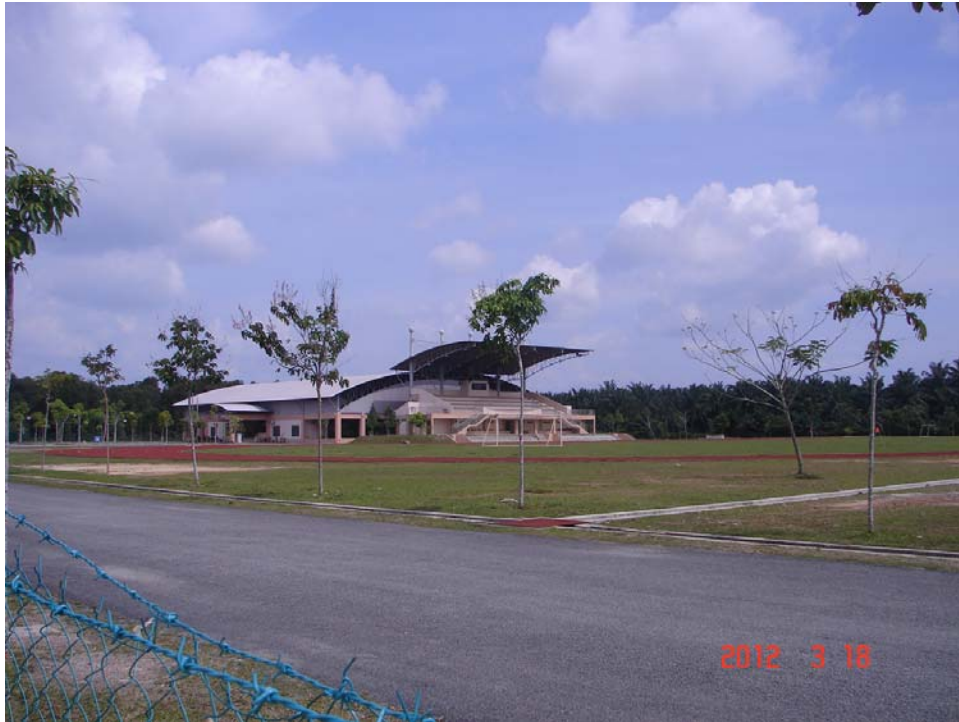
Fig. 3: Oblique view of the indoor game hall, grandstand and football field.

The KUIM mini-stadium consists of a grandstand, an indoor game hall, a football field and an athletic track. The grandstand, which is located about 5 m from the athletic track, is a metal roofed structure with a dimension of about 10 m high, 12 m wide and 16 m long. The metal roof is mounted on five large 12 m high metal poles (Figs. 3 and 4).

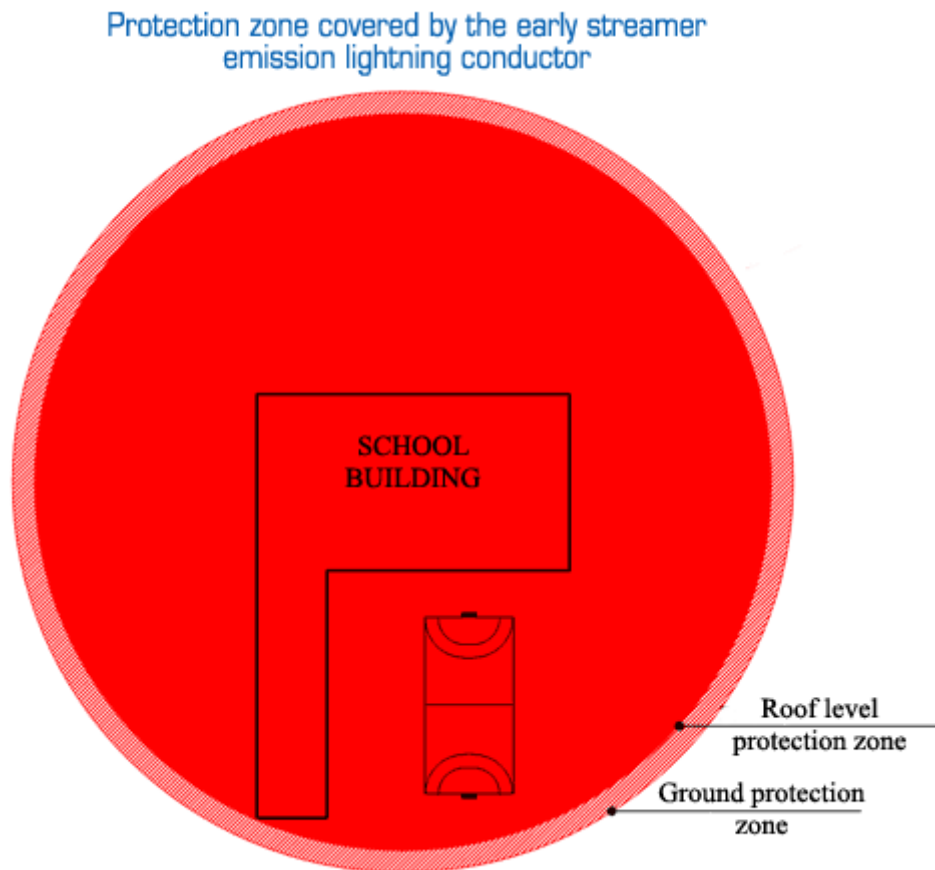
However, the manufacturers of the ESE lightning rods had claimed that their rods can provide a very large protection zone i.e. up to 100 m or more depending on the make and model of the rod. According to GIMELEC, an organisation that is affiliated to French ESE manufacturers, a single ESE lightning rod installed centrally on the roof can provide protection for the entire building and the open area surrounding the building. This is shown in the GIMELEC diagrams below (figs 8 and 9).

Fig. 9: The claimed protection zone provided by the single ESE lightning rod for the school building and surrounding area. (Source: GIMELEC)
